APPENDIX “B”
PRESERVING A COMMUNITY

Historic Rehabilitation Standards and Guidelines
for
THE VILLAGE OF THOMPSONVILLE
Enfield, Connecticut

The Town of Enfield
Enfield Planning and Zoning Commission in
cooperation with the
Enfield Revitalization Strategy Committee

March 2009

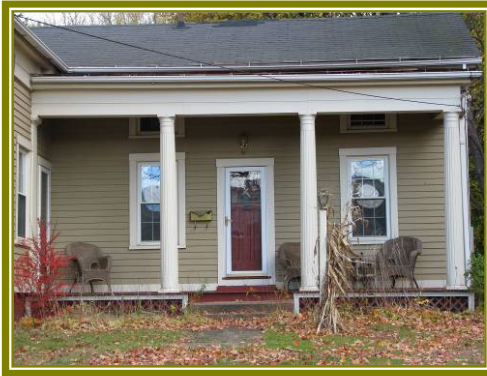
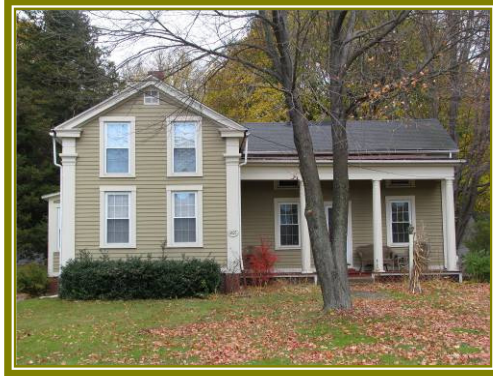
Exceptional vernacular Greek Revival with typical Enfield 'el' wing – Enfield St. - ca. 1850

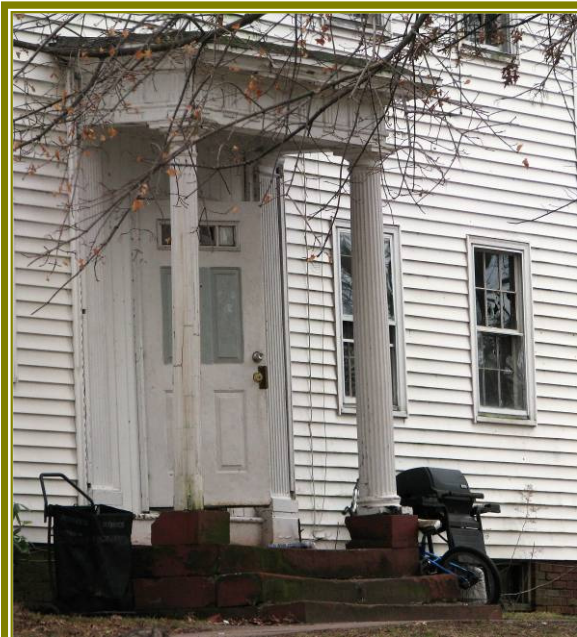
22 Prospect St., 1st house of Henry Thompson

Reflecting the admiration that our new country had for the democratic ideals of ancient Greece, churches and houses were based on the form of a Greek temple. The gable end of the house, representing the temple front, faces the street, usually highlighted by a pediment across the gable peak. Narrow attic windows may be found in the wide frieze board that often runs around the house under the eaves and the pediment. Corner pilasters or boards represented the columns of the temple.

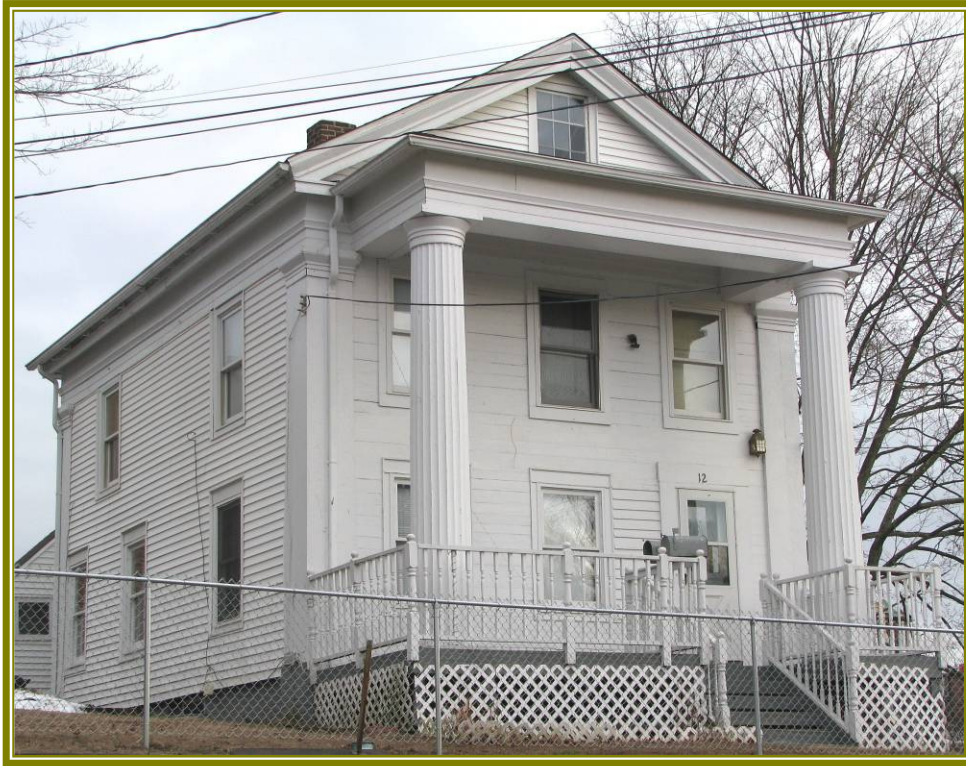
Carpet Company Superintendent's House – 12 Pleasant Street - ca. 1840

One of the more high-style examples, the mill superintendent's house on Pleasant Street, displays a two-story, colonnaded façade porch. Clapboards were usually used for siding, although occasionally flush boards were selected to give the appearance of the smooth stone walls of a temple. Houses and churches of this style were always painted white or in a very light color to look like marble.

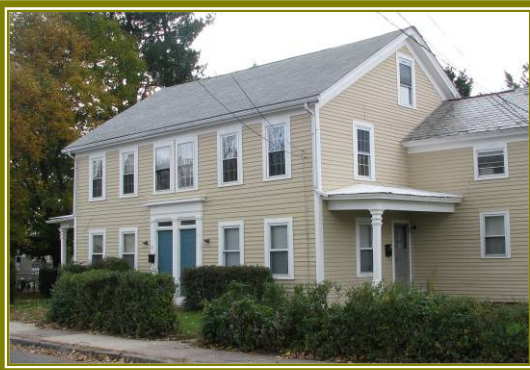
**Multi-family (or tenement)
Greek Revival House– Pleasant
Street - ca. 1860**

A number of the multi-family workers' houses built by the carpet company along streets near the mills illustrate the more common local version of this style. These tenements, as rental properties were once known, were built of brick or wood and some have slate

roofs. Plain boards trim the windows and outline the sills and corners of the wood-framed examples. Style is often expressed just by Greek Revival doorways, which display wide pilasters and high entablatures, as shown here in this Pleasant Street example. Double-hung windows associated with this style usually have six panes in each sash and narrow muntins. Greek Revival cottages often have narrow three-pane attic windows under the eaves.

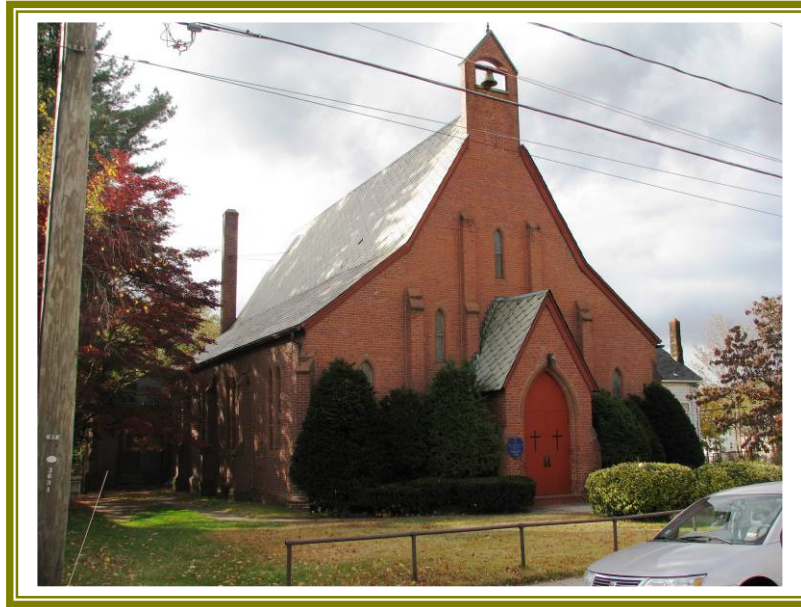
A popular style for both houses and churches, the Gothic Revival is characterized by steeply pitched roofs and pointed-arch windows. In Thompsonville, St. Andrew's Episcopal Church on Prospect Street (above)

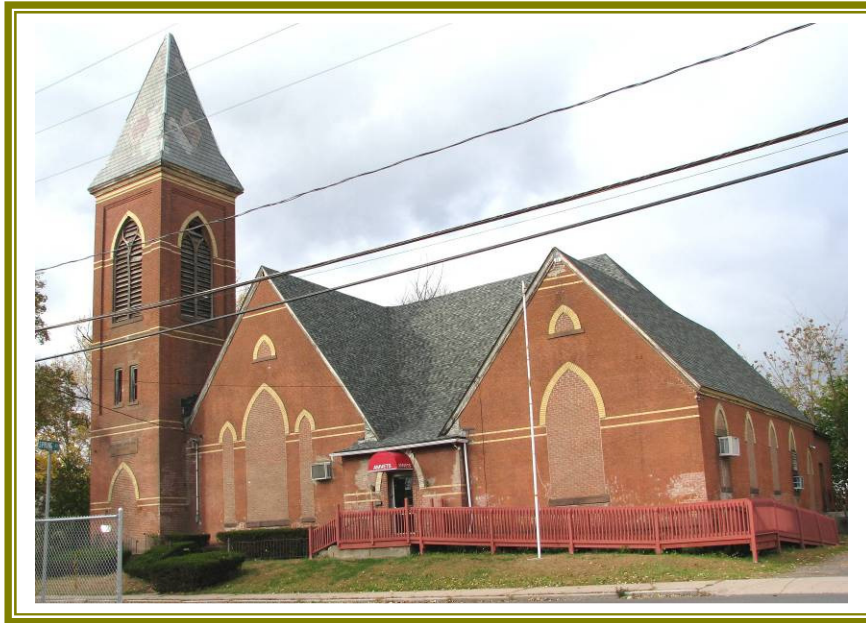
and the former United Methodist church (above) on High Street exemplify this formal style.

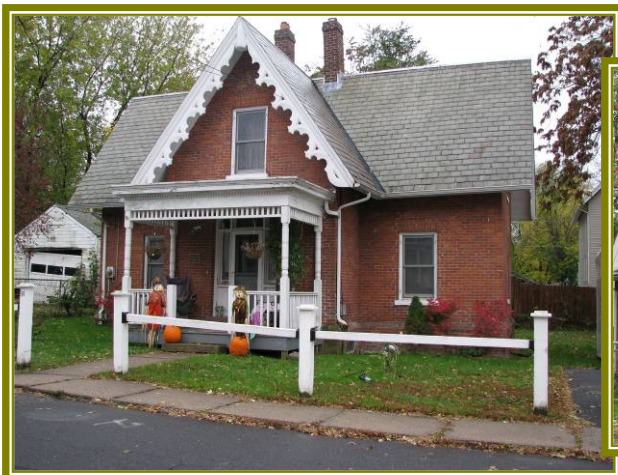
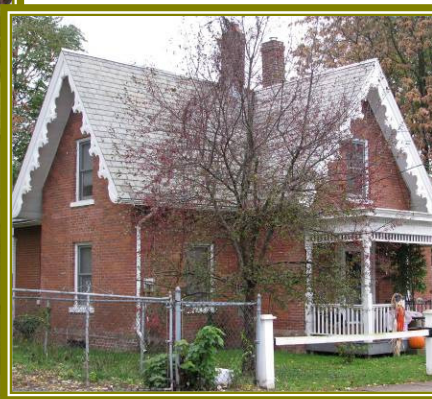
One of the Carpenter Gothic cottages on Cottage Green, ca. 1848 and possibly designed by Alexander Jackson Davis

As interpreted by local builders, the so-called Carpenter Gothic style, may include vertical board-and-batten siding and decorative bargeboards or trusses in the gable peaks. A small group of Carpenter Gothic cottages were built around Cottage Green for the employees of a hosiery factory. Henry Thompson, the factory owner, lived nearby on Prospect Street in the best preserved example of this type in the village (▼).

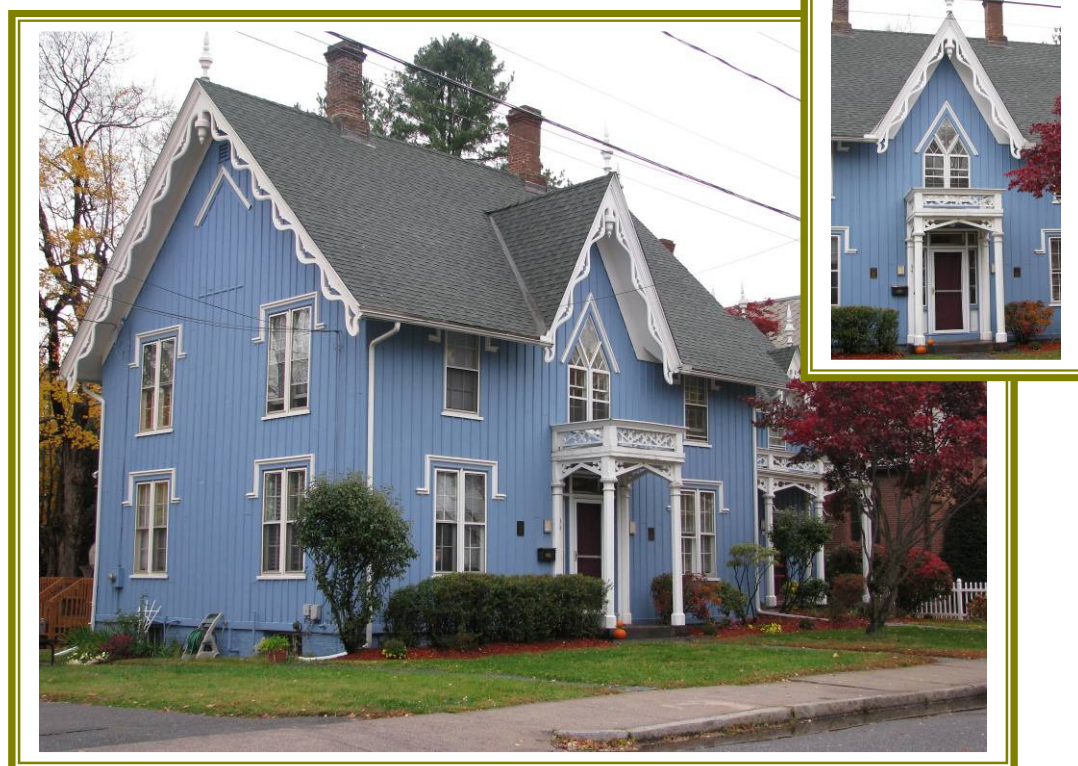
Henry Thompson's second house in Thompsonville at 34 Prospect Street, designed by Alexander Jackson Davis in 1848, constructed ca. 1850. His first house was the heavily modified Greek Revival at 22 Prospect Street.

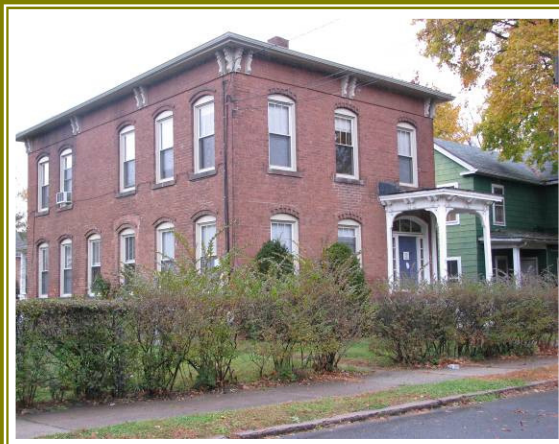
◀ 33 Windsor Street – ca. 1880

A characteristic Italianate entrance porch with chamfered and bracketed posts highlights the brick, cube-form are found in one example Italianate on Windsor Street. Its segmental-arched windows are detailed with hood molds on the side elevations and brick diaper work on the façade.

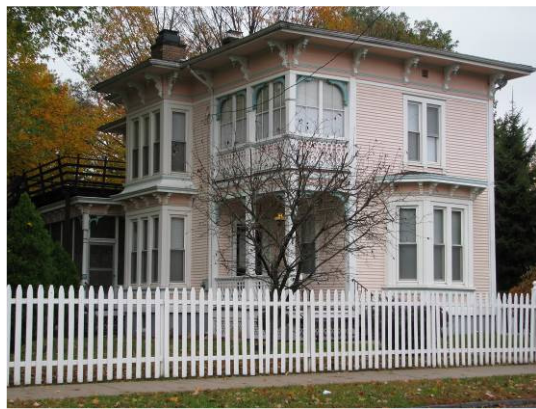
2-story porches and full height bay windows at
158 Pearl Street – ca. 1881

Two-story porches, as well as full-height bay windows are featured on two similar Italianates on Pearl Street.

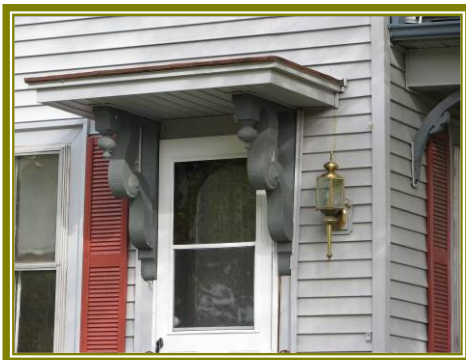
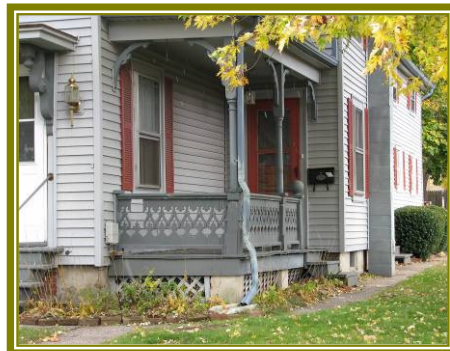
Ca. 1880 Italianate – Russell Street

A door hood supported by scrolled brackets with drops and an exceptional side porch with a

pierced balustrade and curved brackets distinguish a circa 1880 Italianate on Russell Street

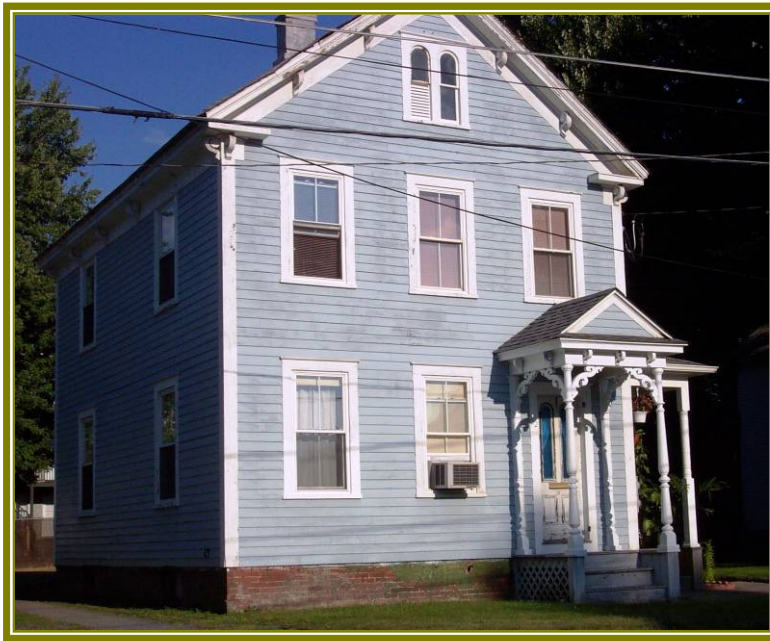
Round-arched gable windows, another style identifier, often paired on the façade, are found on the neighboring Vital Courmier house (ca. 1878), which also has two arched glass lights in the front door, as well as delicate eave brackets and a fully detailed front porch.

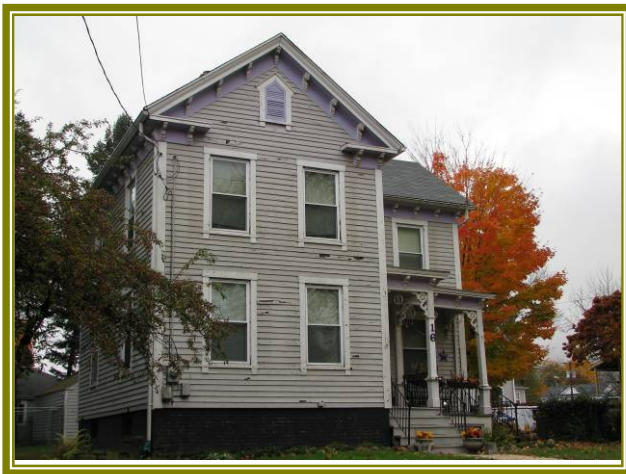
A touch of Gothic Revival is found in the pointed gable windows that highlight the gable peaks of neighboring houses on New King Street. Two-over-two, double-hung sash is typical for this and other later nineteenth-century styles.

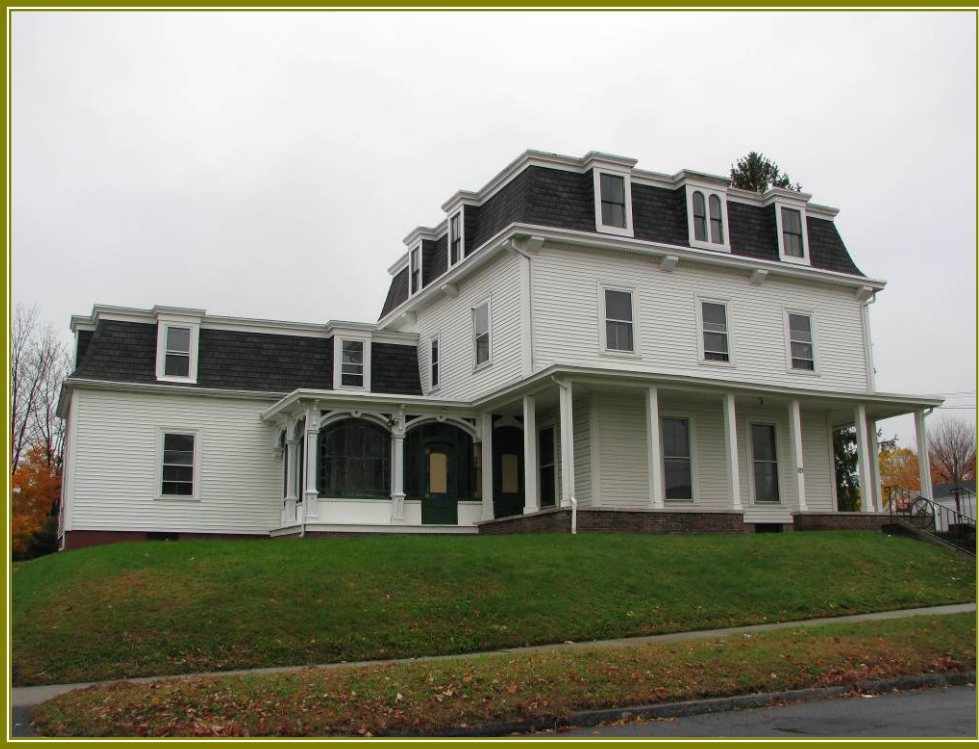
The David Brainerd House (ca. 1880) on Pearl Street (a.k.a. the Masonic Lodge) is one of only two examples of this style in the village. The 2nd is on Alden Avenue (below), also ca. 1880.

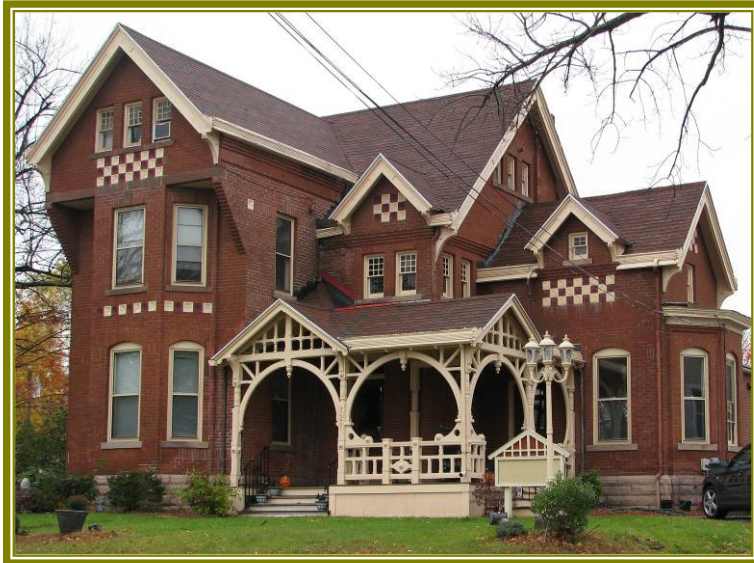
English architecture. In contrast to the box-like forms of earlier styles, larger more stylish Queen Annes are characterized by a variety of forms, towers or turrets, wings, and bays, often joined together by a wraparound veranda. Although the veranda has been enclosed, the Robert Hilditch house ◀ (now an apartment house) on Pearl Street exemplifies this newer asymmetrical massing.

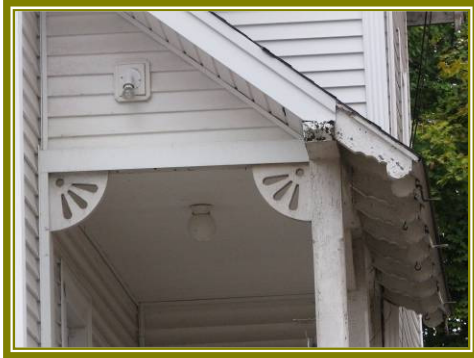
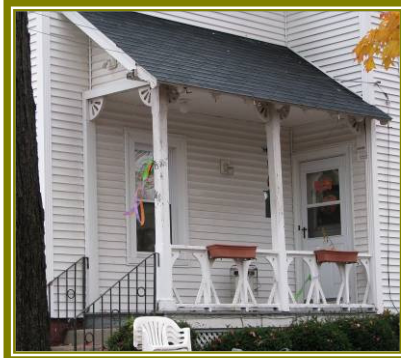
The Guido Mazzini House on Prospect Street ▲, one of the best preserved multifamily examples, has retained many original Stick-style features, including fish-scale shingling. It also has matching side porches with scrolled and pieced designs, decorative gable trusses, and exposed rafter tails.

The bay windows of the Italianate style now display decorative brackets at the cut-away corners, as shown here on the Julius Smith house on Garden Street. ►

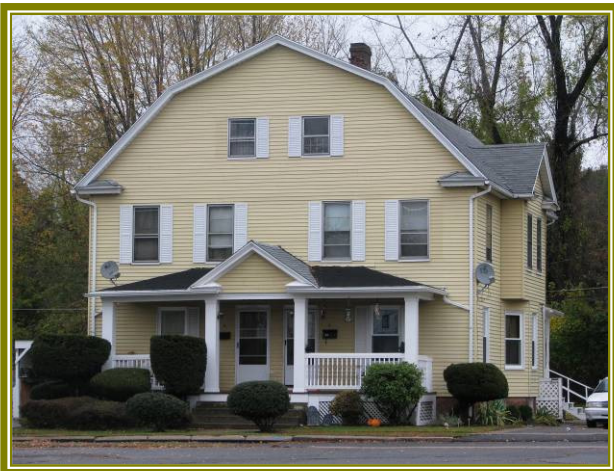
◀ Hartford Ave.
Colonial Revival

A simplified version of this basic design is found in the multi-family Colonial Revivals on Hartford Avenue and Bigelow Avenue. Built by the carpet company just prior to World War I, they have alternating gambrel and gable roofs to add variety to the streetscapes. On side elevations, pedimented wall dormers incorporate first-floor bay windows with Queen Anne cut-away corners.

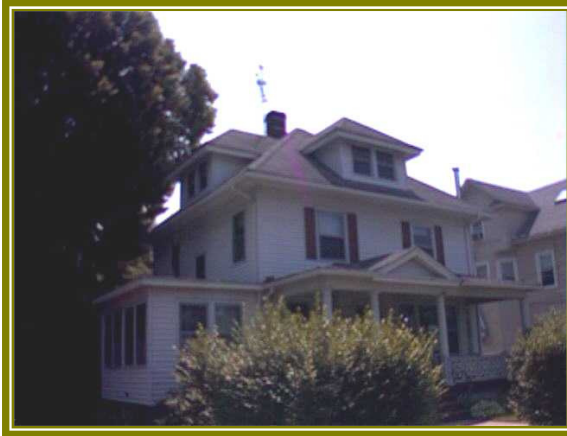
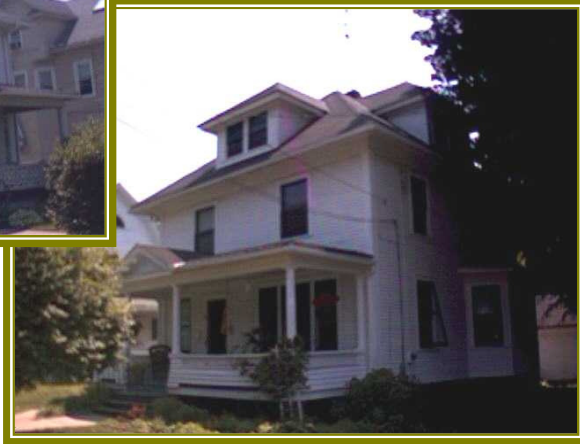
▲ Franklin Street ►

The Four-Square, one of the more popular Colonial Revival sub-types in Thompsonville, is nearly square in plan, and always has a hipped roof.

A high style example on Enfield Street might typically incorporate Colonial Revival elements, such as the portico with freestanding and engaged columns and diamond pane windows. The sun porch is also typical of the Colonial Revival period. An exceptional collection of Four-Squares on Franklin Street all display the gabled roof dormers associated with this style.

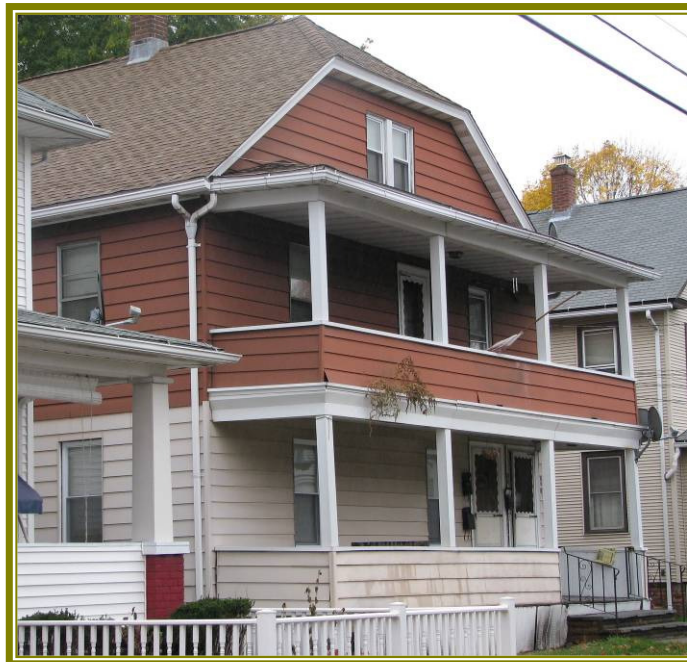
An unusual double-decker variant of the Four Square, which has docked facade gables, was introduced on upper Windsor Street. in the 1920s. ►

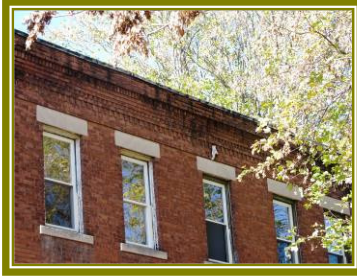
4 Thompson Ct. ▲

In Thompsonville the Neo-Classical Revival style is generally reserved for schools, apartment buildings, and large commercial blocks, all built of brick in the early 20th century. Like the architecture of the early 1800s, the first classical revival period, this style relies on the detailing and massing of ancient Greek and Roman architecture. Simple expressions of this style are found in the wood and brick cornices on the Thompson Court apartment buildings,

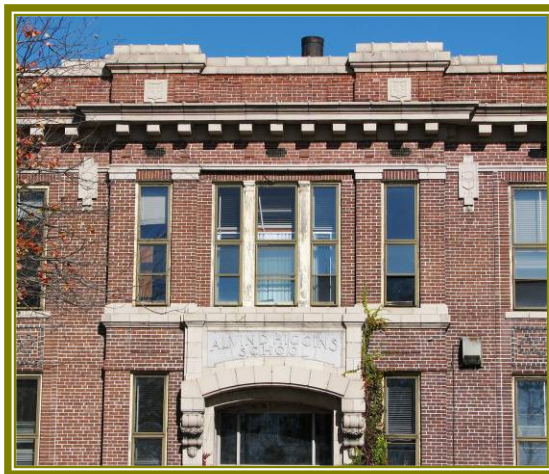
◀ - in the cornice modillions of the Higgins School on North Main Street,

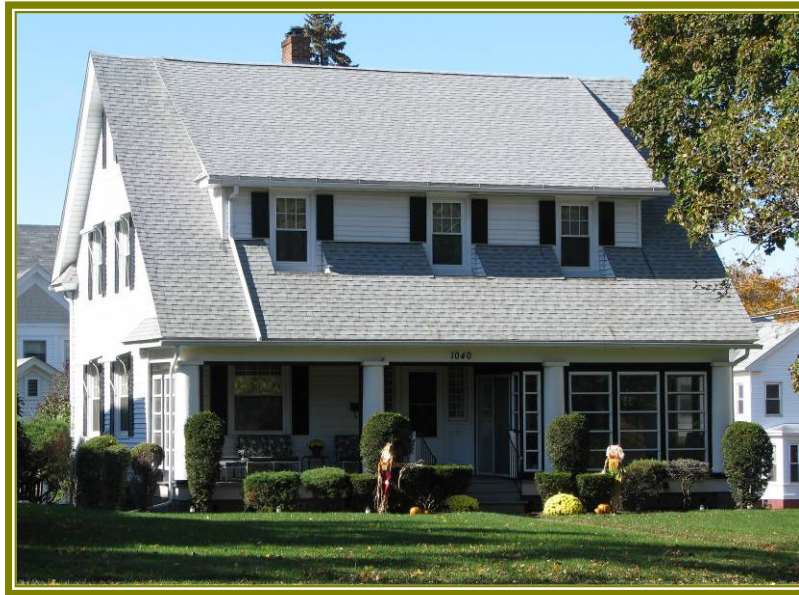
One of the more stylish examples ▲ was built by William J. Hines on Enfield Street, in which shed dormer windows are set down into the slope of the façade porch roof, which is supported by short, massive columns.

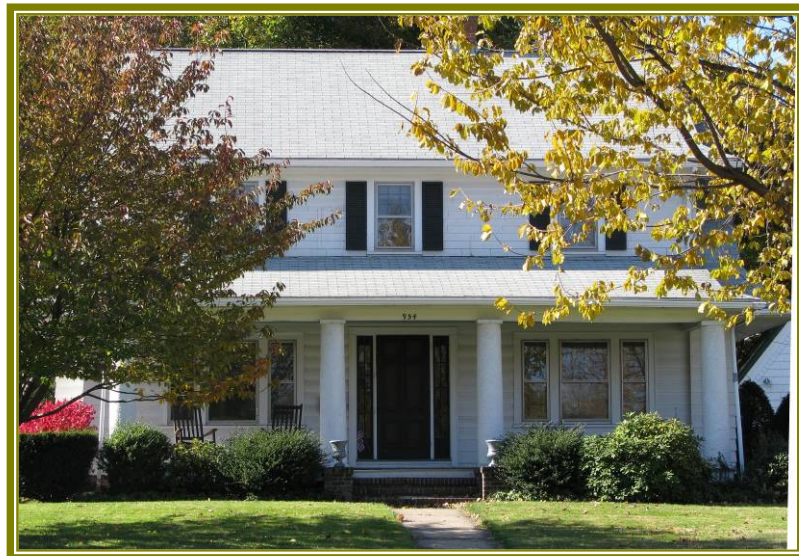
In some Thompsonville bungalows ▲, the porch has a separate shed roof.

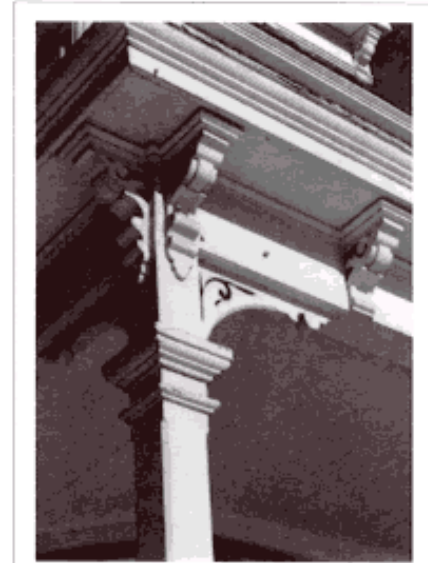
Wooden ornamental trim such as this can be duplicated with a jigsaw or purchased from reproduction catalogs

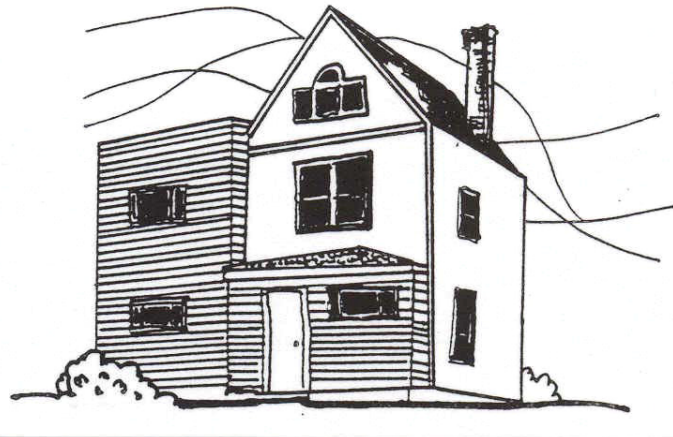
INCOMPATIBLE ADDITION:

- ◆ Different Roof Shapes
- ◆ Different Windows
- ◆ Different Materials
- ◆ Enclosed Front Porch

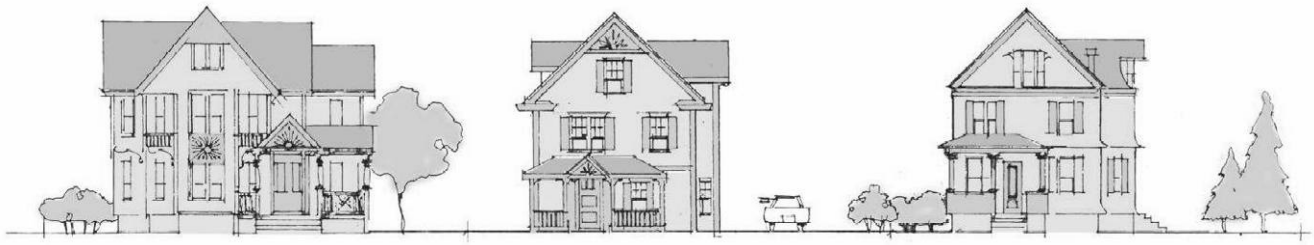
An appropriate infill house (center) on a traditional street

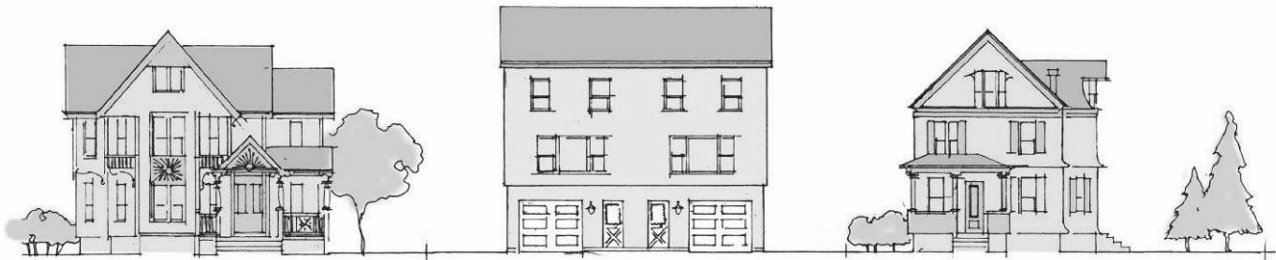
An inappropriate "tuck under" infill house (center) on a traditional street

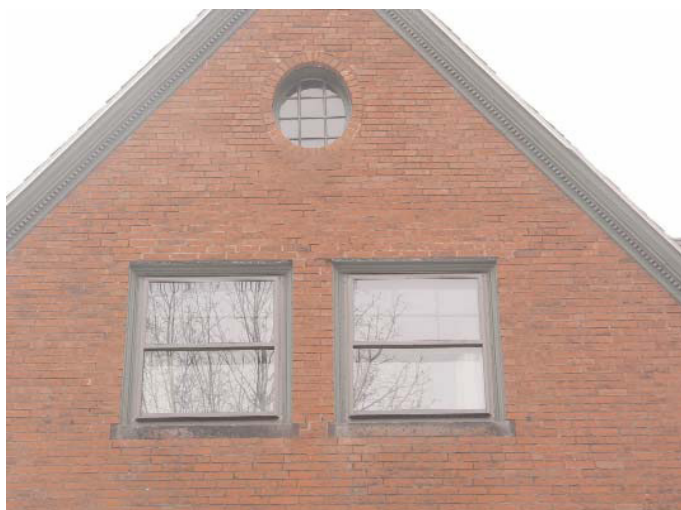
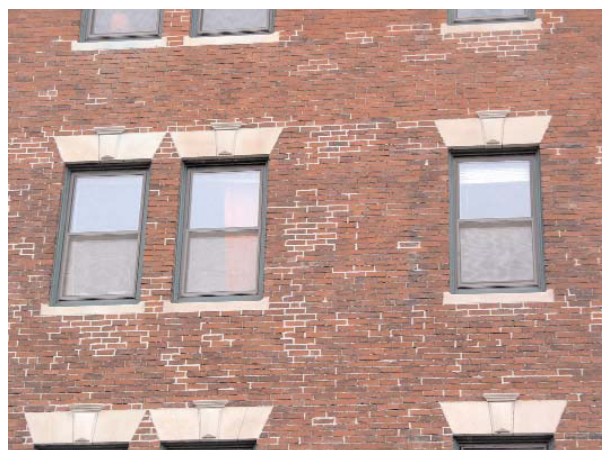
Repoint and repair masonry before power-washing to avoid water penetration inside the walls.

These two examples show the importance of re-pointing using mortar that matches the original in material, color and joint profile. In the example above, the historic appearance of the masonry has been maintained. The example on the right shows poor re-pointing that has altered the historic appearance of the building and will accelerate the deterioration of the brick.

New mortar should match the color and composition of the original. Always match the width, shape, texture, and depth of the original joints. Old mortar should be raked out to at least $\frac{3}{4}$ ” before proceeding. The color of many 19th-century mortars came from the sand in the mix, but powdered dyes are used today. Avoid re-pointing with standard bagged mortar mix, which is usually too light in color. Not only will the re-pointed area stand out like a sore thumb, modern mortar is often too hard and may cause the softer historic brick to break off, or spall at the edges.

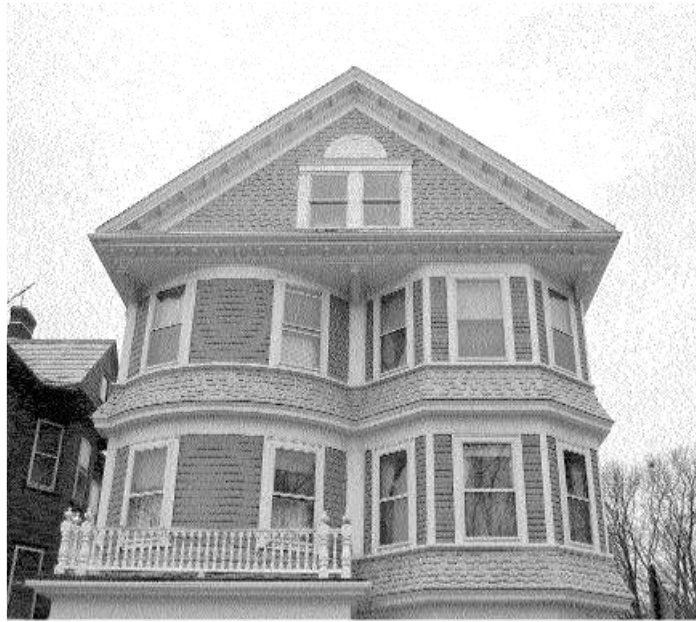
Building with exterior siding and ornamental trim intact

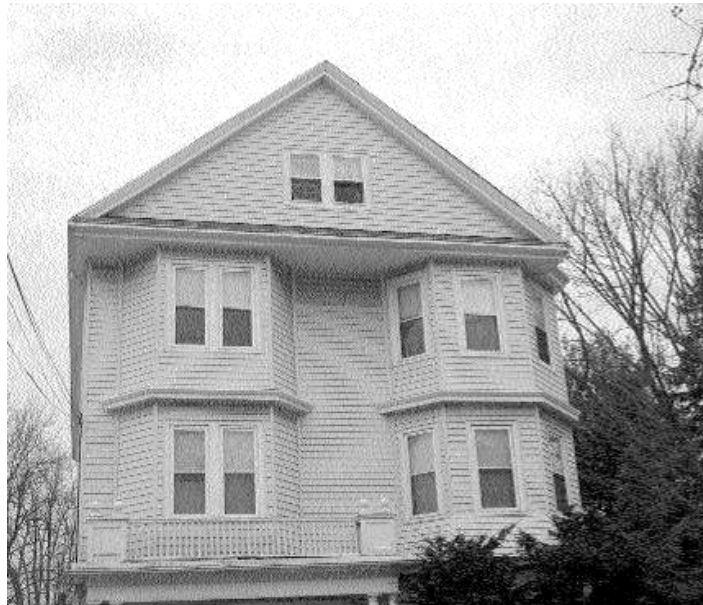
Building with original siding and ornamental trim covered or removed

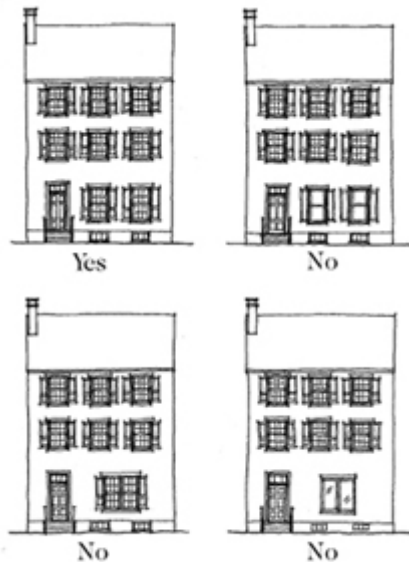
Preservation of the pattern and rhythm of historic windows is important to the harmony and texture of the building facade and the streetscape. Replacement of six-over-six sashes with one-over-one sashes destroys the scale of the windows (top right). Combining two windows into a single “picture window” or band of windows destroys the rhythm of the facade (bottom left and right). Modifying the alignment of windows and doors in each bay weakens the order of the facade.
